# Manhole Inspection Summary

Manhole # S23A\_\_037MH

Insp Date: **7/27/07 8:32 AM**

**Location** Address: **720 GILMORE ST**

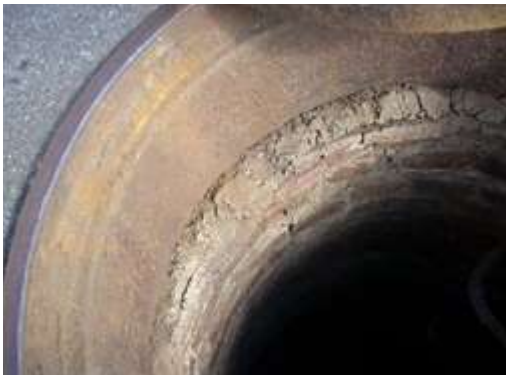
Defect 1

Offset: **2** (in.)

FRAME OFFSET

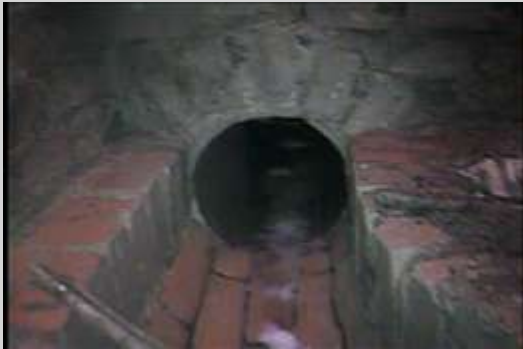
12 O'Clock Outflow

8 in. Circular Gravity Sewer  
Pipe Out @ 12 O'Clock

Pipe Height: **7.2** (in.) Rod and Bar (Angled)  
Pipe Material: **Clay** ☐ Pipe Lined  
Invert Depth: **11.90** (ft.) Flow Characteristics: **Slow**  
Deposits: ☐ None ☐ Mud ☐ Sludge ☒ **Debris** ☐ Grease  
Silt Depth: **1** (in.) Deposits Extent: **Light**  
Infiltration: **None** Pipe Seal Cond: **Sound**

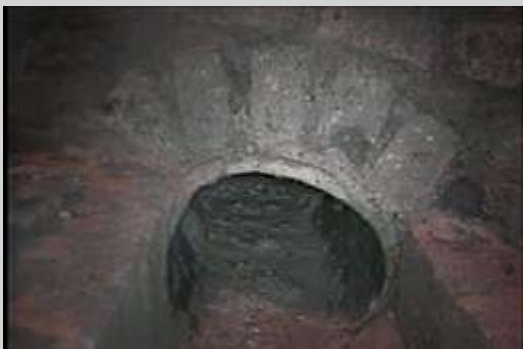
3 O'Clock Inflow

8 in. Circular Gravity Sewer  
Pipe In @ 3 O'Clock

Pipe Height: **7.2** (in.) Rod and Bar (Angled)  
Pipe Material: **Clay** ☐ Pipe Lined  
Invert Depth: **11.64** (ft.) Flow Characteristics: **Slow**  
Deposits: ☐ None ☒ **Mud** ☐ Sludge ☐ Debris ☐ Grease  
Silt Depth: **2** (in.) Deposits Extent: **Medium**  
Infiltration: **None** Pipe Seal Cond: **Sound**

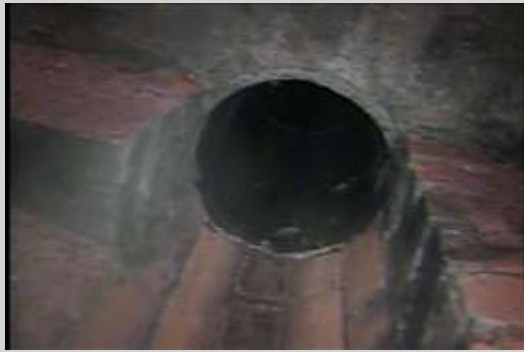
6 O'Clock Inflow

8 in. Circular Gravity Sewer

Pipe In @ 6 O'Clock

Pipe Height: **7.2** (in.) Rod and Bar (Angled)

Deposits: ☒ None ☐ Mud ☐ Sludge ☐ Debris ☐ Grease

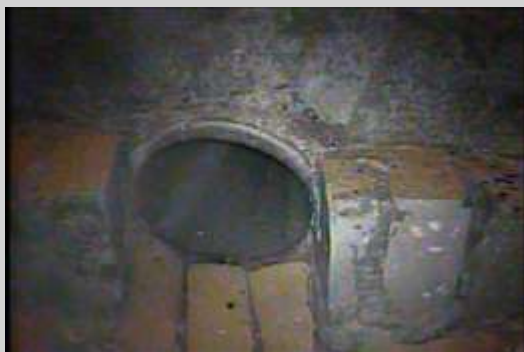
9 O'Clock Inflow

6 in. Circular Gravity Sewer

Pipe In @ 9 O'Clock

Pipe Height: **6** (in.) Rod and Bar (Angled)

Deposits: ☒ None ☐ Mud ☐ Sludge ☐ Debris ☐ Grease
